Manhole Inspection Summary

Manhole # S67I__004MH

Location Address: **600 Dundalk Ave.**

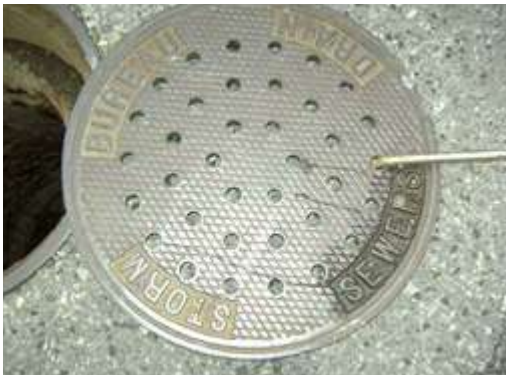
Defect 2

Comments **MH HAS STORM DRAIN MH COVER**

Properties: ☐ Bolted ☒ Vented ☐ Water Tight ☐ Water Tight Insert

Vented storm sewer MH cover on sanitary sewer

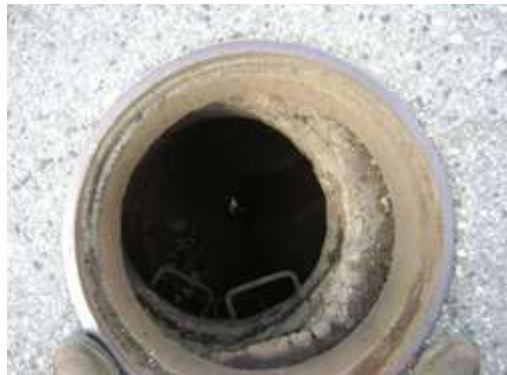
Defect 1

Frame Offset: **4** (in.) Condition: ☐ Sound ☐ Cracked ☒ **Leaks**

Offset frame

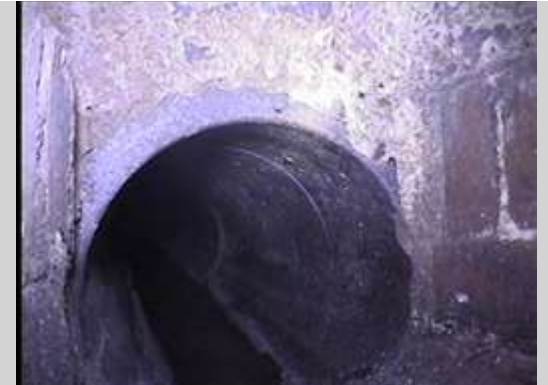
12 O'Clock Outflow

10 in. Circular Gravity Sewer
Pipe Out @ 12 O'Clock

Pipe Height: **10.8** (in.) Rod and Bar (Angled)
Pipe Material: **Clay** ☐ Pipe Lined
Invert Depth: **8.83** (ft.) Flow Characteristics: **Slow**
Deposits: ☒ None ☐ Mud ☐ Sludge ☐ Debris ☐ Grease
Silt Depth: (in.) Deposits Extent:
Infiltration: **None** Pipe Seal Cond: **Sound**

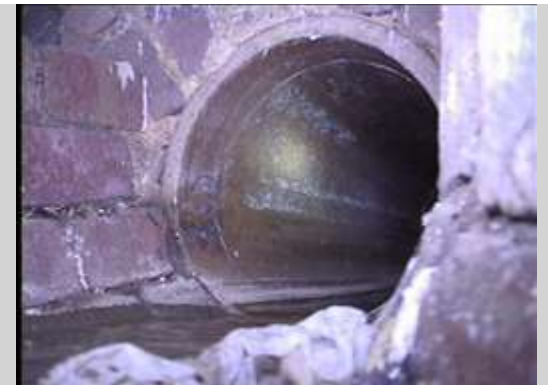
8 O'Clock Inflow

10 in. Circular Gravity Sewer
Pipe In @ 8 O'Clock

Pipe Height: **10.8** (in.) Rod and Bar (Angled)
Pipe Material: **Clay** ☐ Pipe Lined
Invert Depth: **8.50** (ft.) Flow Characteristics: **Slow**
Deposits: ☒ None ☐ Mud ☐ Sludge ☐ Debris ☐ Grease
Silt Depth: (in.) Deposits Extent:
Infiltration: **None** Pipe Seal Cond: **Sound**
